SC Inspector, LLC  
215 Brenleigh Ct  
Simpsonville SC 29680  
864-419-7577  
jimsofet@scinspector.com

Report: 0000004

## Confidential Inspection Report 149 Longwood Lane Anywhere, SC 29600

November 11, 2010

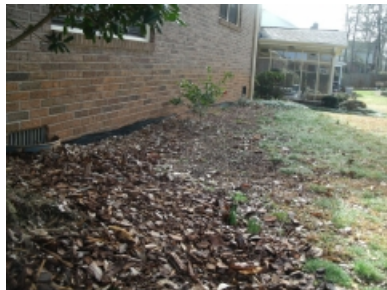
##### *207 Lot Grade at Foundation:*

1. Lot grade within six feet of structure is flat at the rear and slopes both toward and away from foundation. The grading should fall away from the foundation at a rate of 1 inch per foot for at least 6 feet to prevent moisture accumulation next to the foundation. Possible water proofing material was observed along the foundation at the rear. No signs of any seepage were noted in the crawlspace. See seller for more information or prior conditions. Suggest improvements as needed.

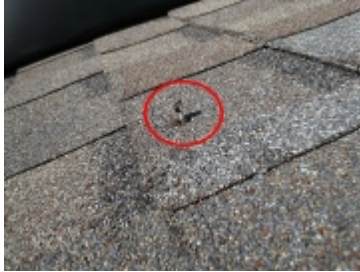
**ROOF COVERING**400 ROOF*406 Conditions:*

2. One nail has popped through the shingle surface at the left side of the main roof near the chimney; nail is raised. Recommend securing the nail head and sealing to prevent moisture penetration.

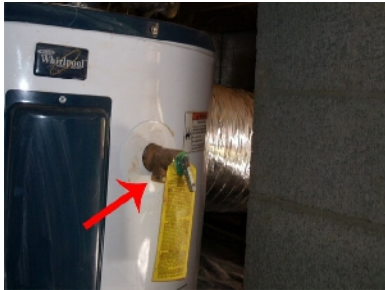
**MAJOR SYSTEMS**WATER HEATER*844 TPR Valve and Drain Line:*

3. The discharge drain pipe is missing on the temperature pressure relief valve. The required  $\frac{3}{4}$  inch discharge pipe needs to be installed draining to daylight or the rear foundation drain to ensure safety.

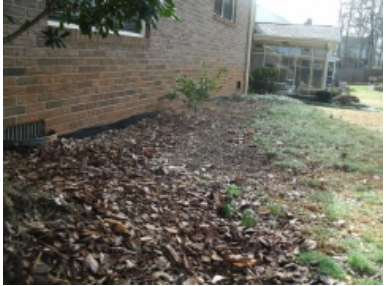
- 204 *Gates:* N/A.
- 205 *Retaining Wall:* None.
- 206 *Sprinklers:* None.
- 207 *Lot Grade at Foundation:* Building is built on a relatively flat lot. Lot grade within six feet of structure is flat at the rear and slopes both toward and away from foundation. The grading should fall away from the foundation at a rate of 1 inch per foot for at least 6 feet to prevent moisture accumulation next to the foundation. Possible water proofing material was observed along the foundation at the rear. See seller for more information or prior conditions.

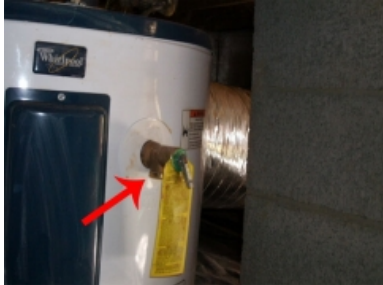
- 840 Location(s): Located at the crawlspace.
- 841 Brand Name(s): Whirlpool.
- 842 Size/Type: Capacity: 46.5 gallon. Electric unit present. No disconnect lockout observed for this unit.
- 843 Supply/Shutoff valve: Supply pipes: Copper. Water heater plumbing supply pipes are insulated. Cold water shutoff valve intact.
- 844 TPR Valve and Drain Line: The discharge drain pipe is missing on the temperature pressure relief valve. The required 3/4 inch discharge pipe needs to be installed draining to daylight or the rear foundation drain to ensure safety.
- 845 Combustion & Air: N/A.
- 846 Condition: The water temperature at time of inspection was between 115 - 125 °F. Do not adjust temperature above 125 °F to prevent scalding.
- 847 Venting: N/A.
- 848 Comments Age: 2004. Water heater sits on bricks and may be subject to premature rusting and deterioration due to moisture.
